*Pole Line Hardware
Construction Specialties*

Thermal Diffusion
Galvanizing
Comparative
1500 Hr B117 Salt
Spray Results

Testing Background

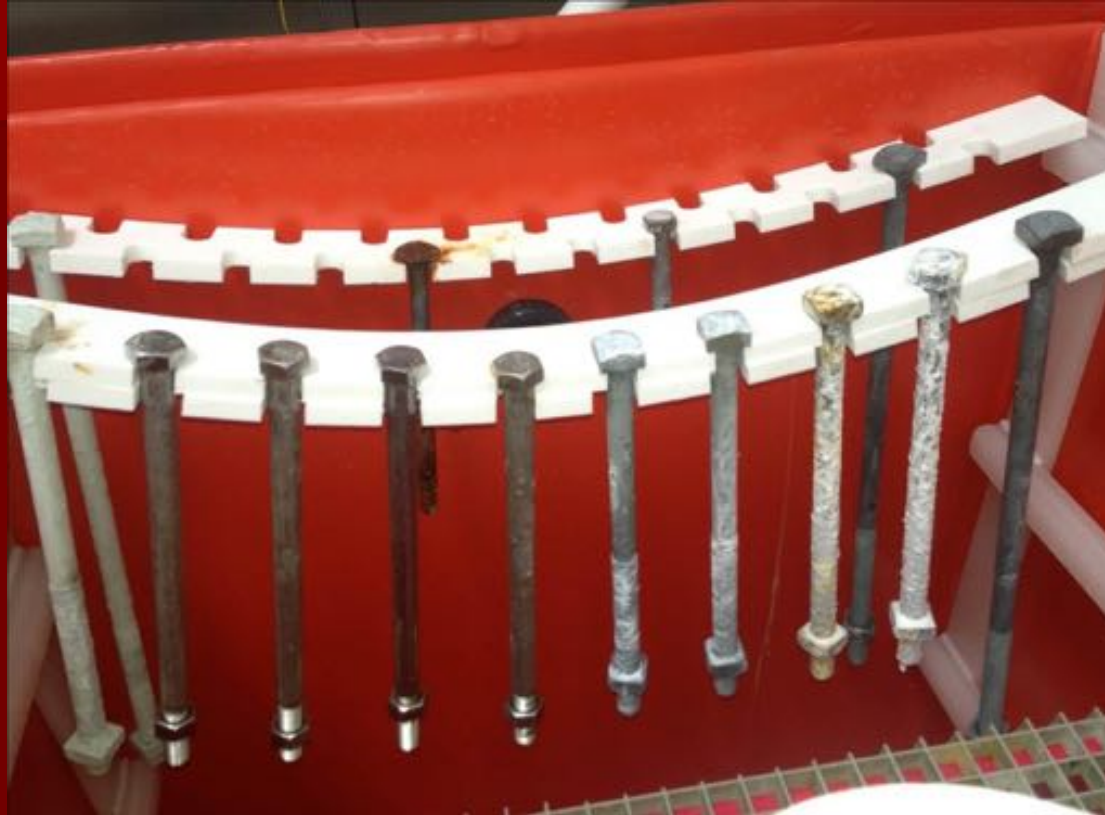
Bolts Tested-Pictured at 500 Hrs

First row from left to right: ERX painted HDG, 316ss, 316ss, 304ss, 304ss, HDG silicate coated, HDG silicate coated, HDG, HDG, TDG

Second row from left to right: ERX painted TDG, Electroplated, Aluminum, TDG

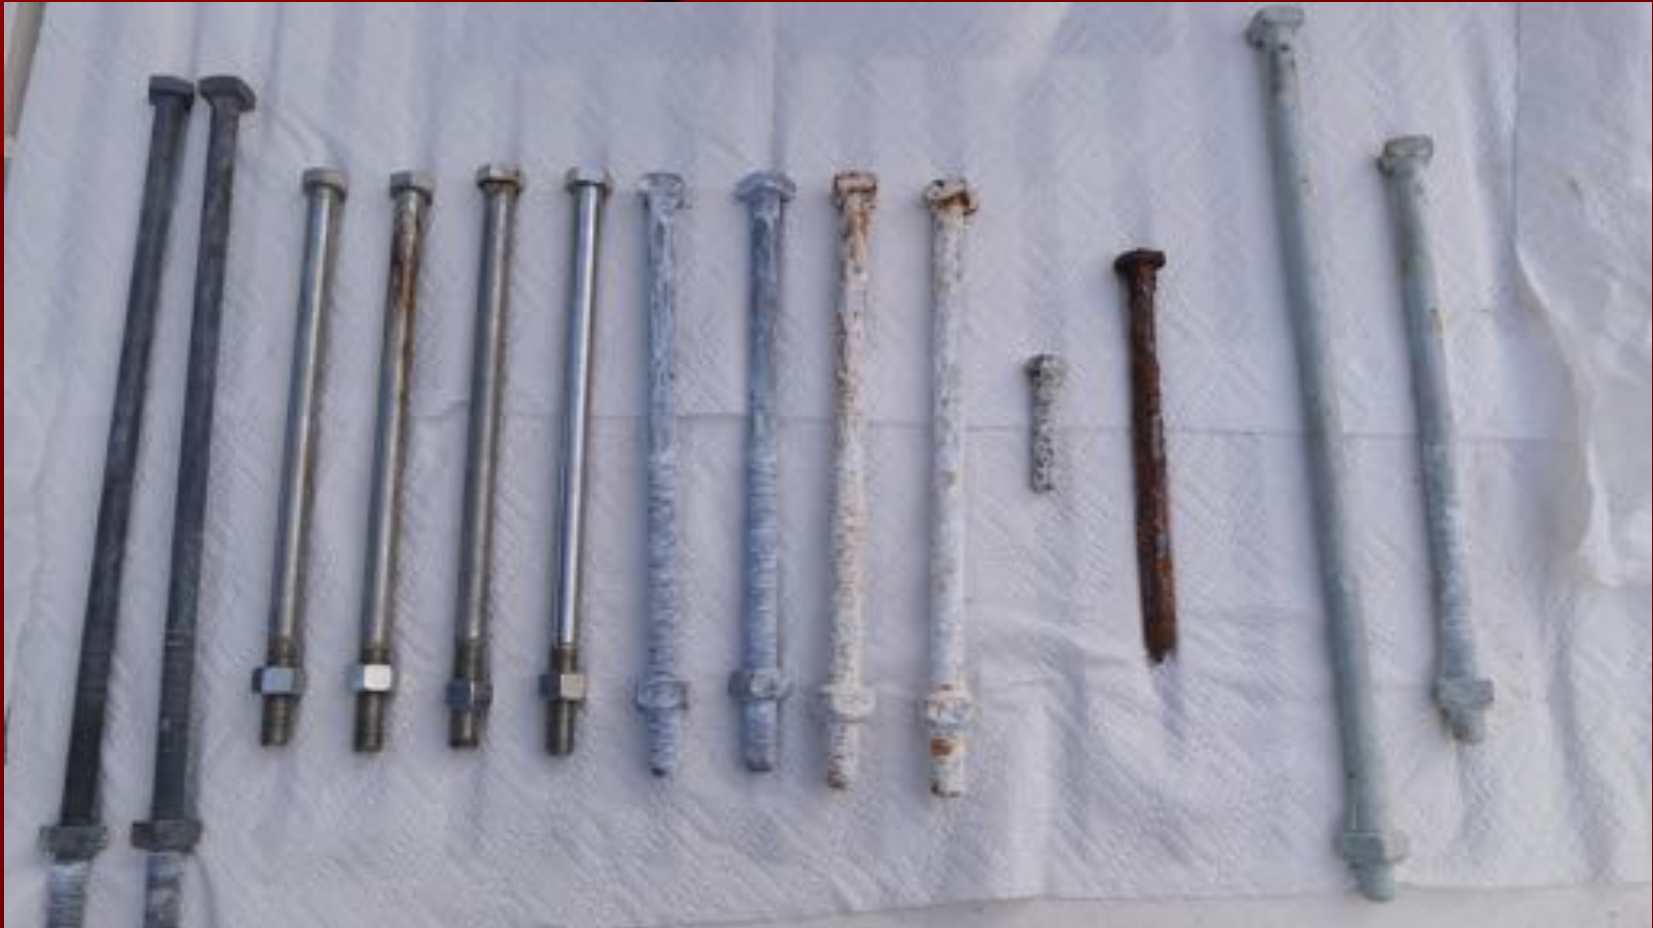
All @ 1500 Hrs

From left to right:

TDG (2), 316 SS (2), 304 SS (2), Silicate Coated HDG (2), HDG (2),
Aluminum(1), electroplated (1), ERX TDG (1), ERX HDG (1)

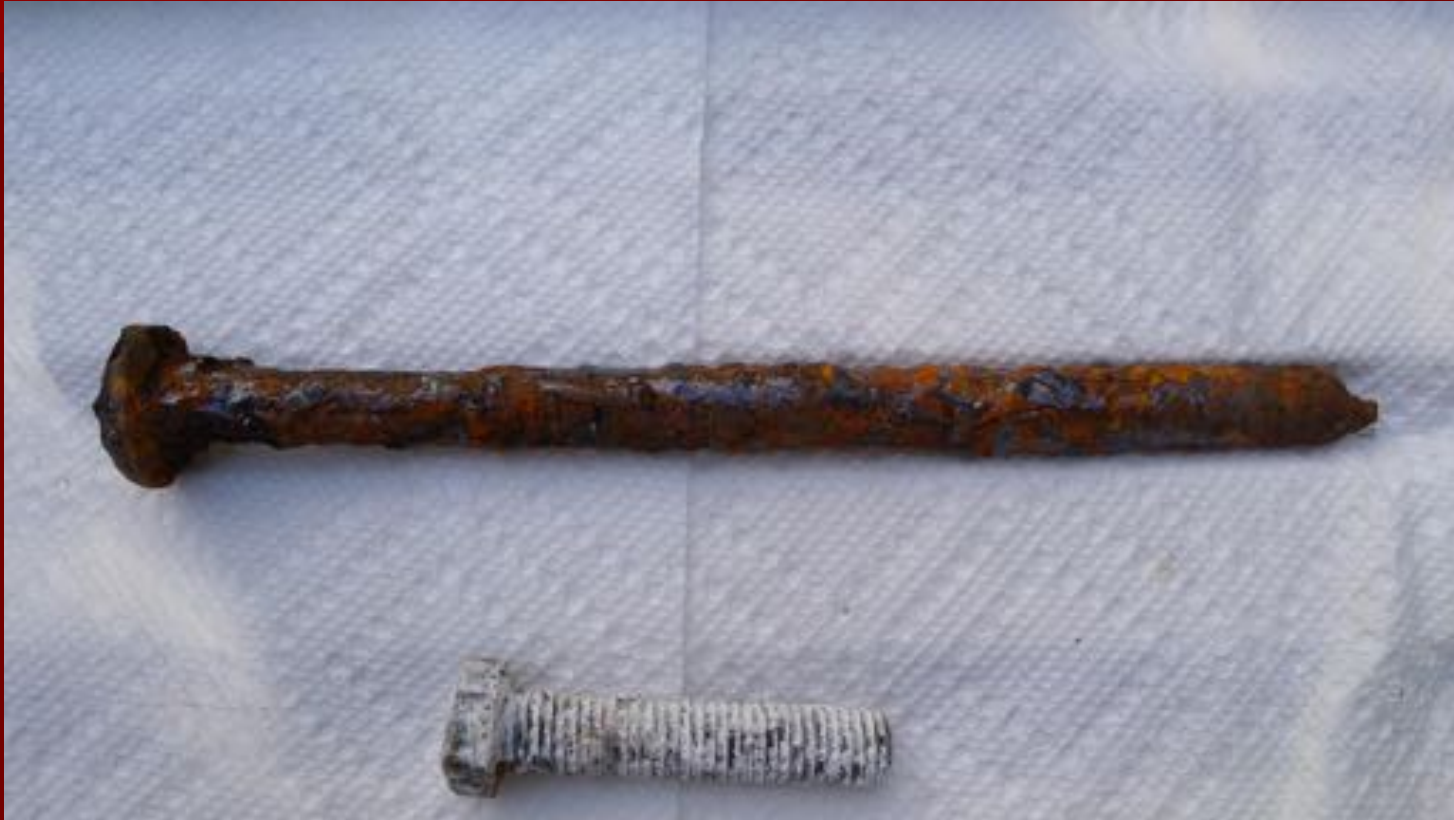
Top-Electro Plated Coated Bottom-Aluminum @ 1500 Hrs

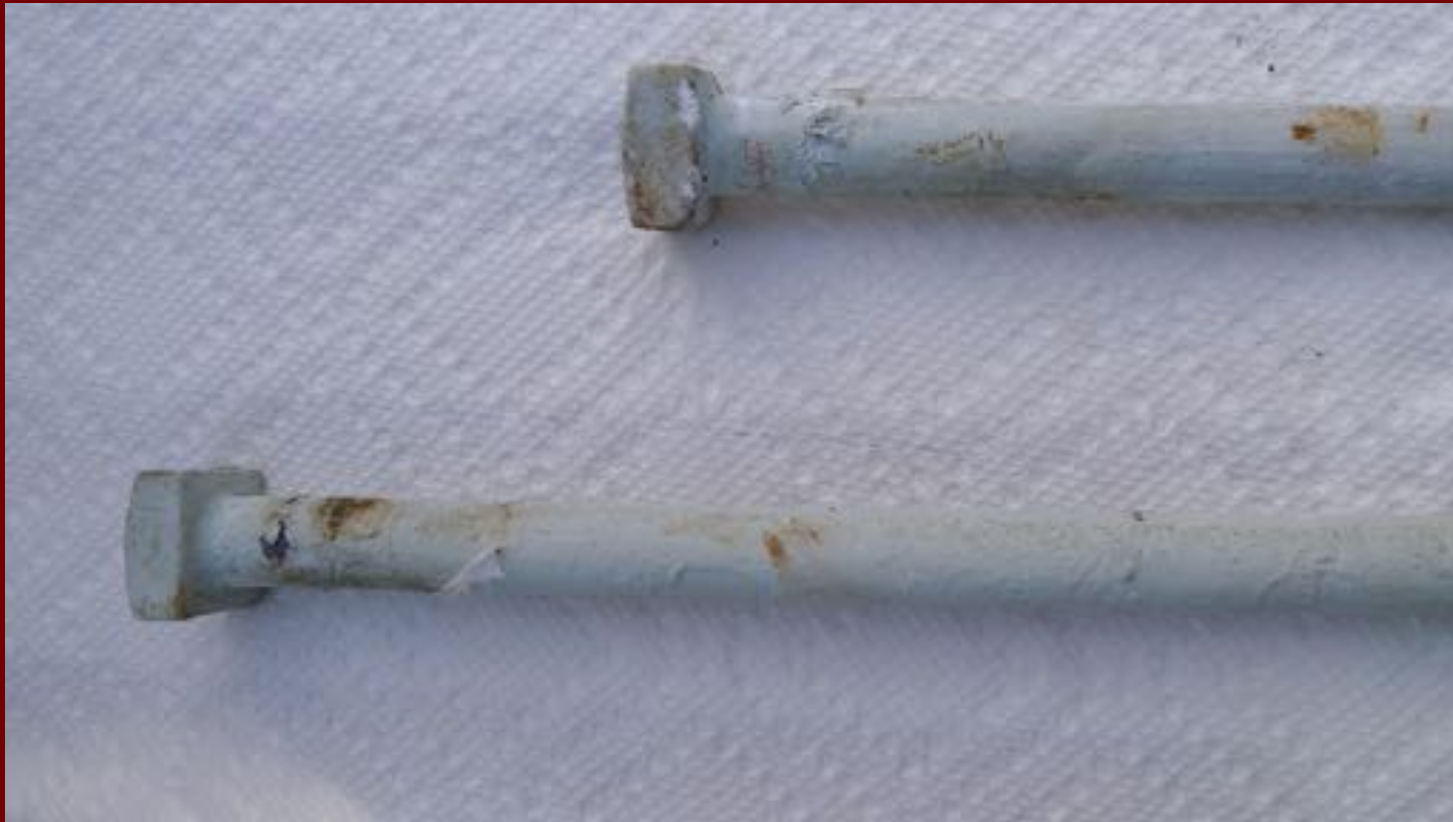
Top-ERX painted on HDG, Bottom ERX painted on TDG @ 1500 Hrs

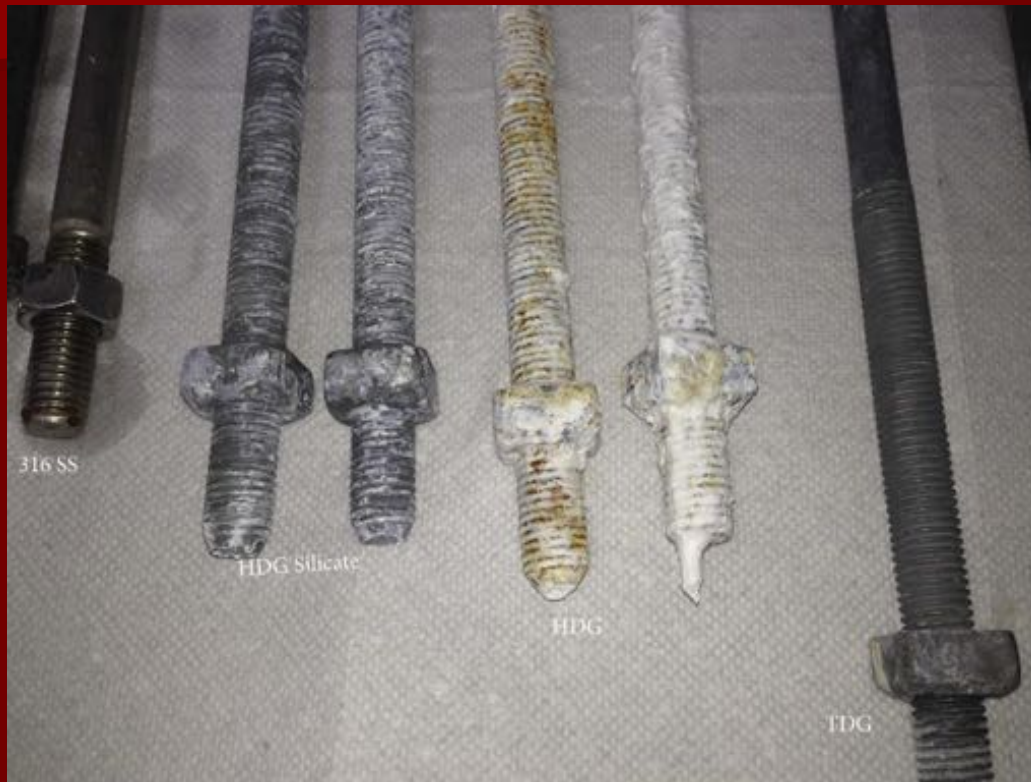
Threads close up @ 1000 Hrs

Thread Status:

316 SS-one minor corrosion point. Usable

HDG Silicate-corroded. Unusable

HDG-Badly corroded. Unusable

TDG-No corrosion. Usable

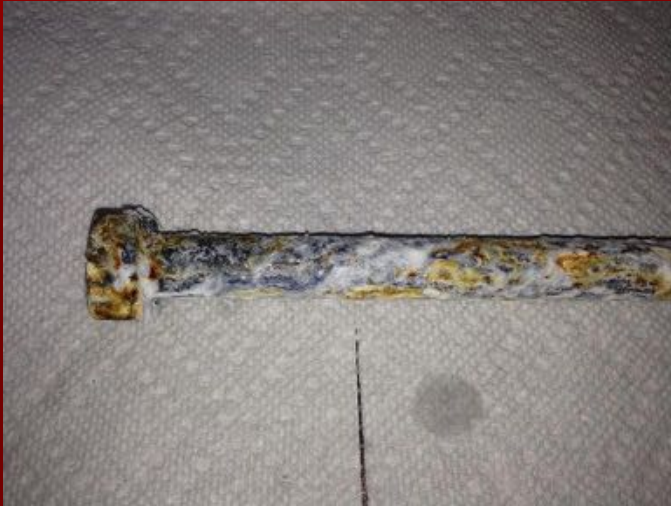
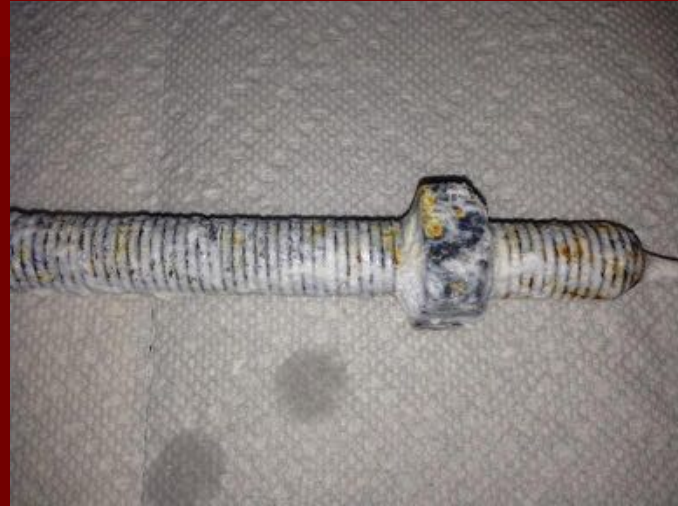
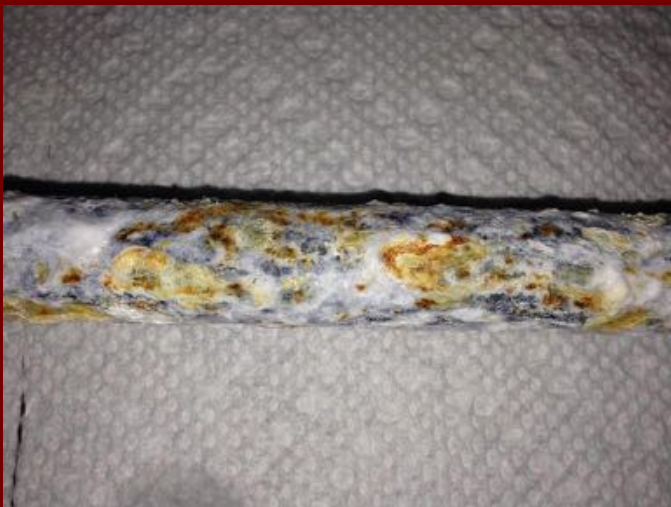
HDG @ 500 Hrs

Status:
Heavily corroded
Frozen Threads
Unusable

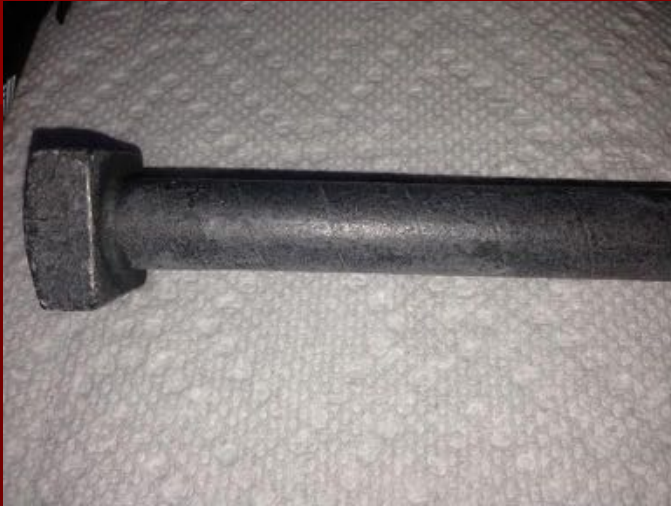
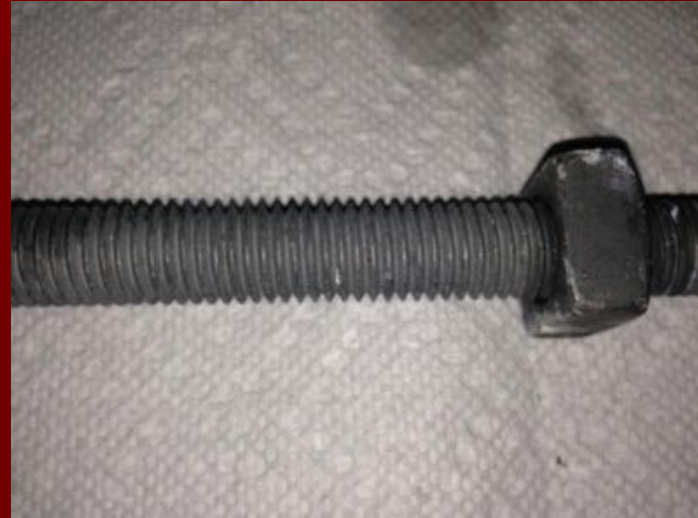
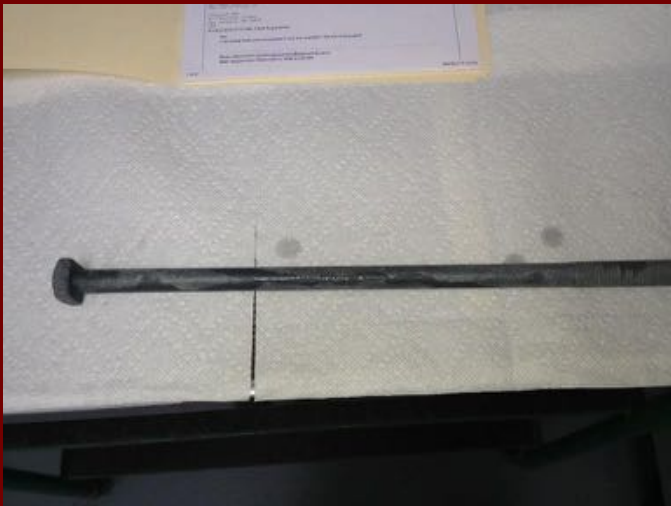
TDG @ 500 Hrs

Status:

Zero corrosion head, body, chamfer.

Free threads with zero corrosion.

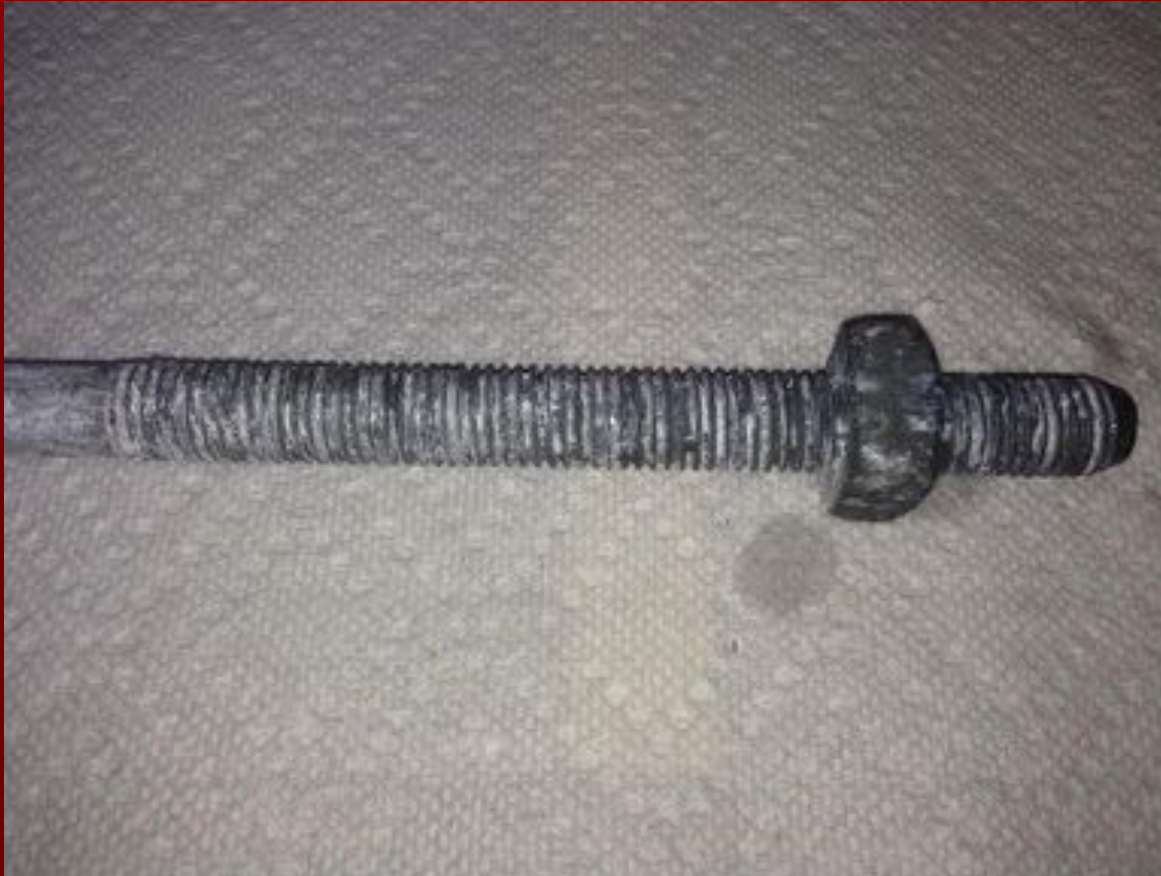
Silicate Coated HDG @ 500 Hrs

Status:

Heavy corrosion
head, chamber,
body, threads.
Frozen Threads,
unusable.

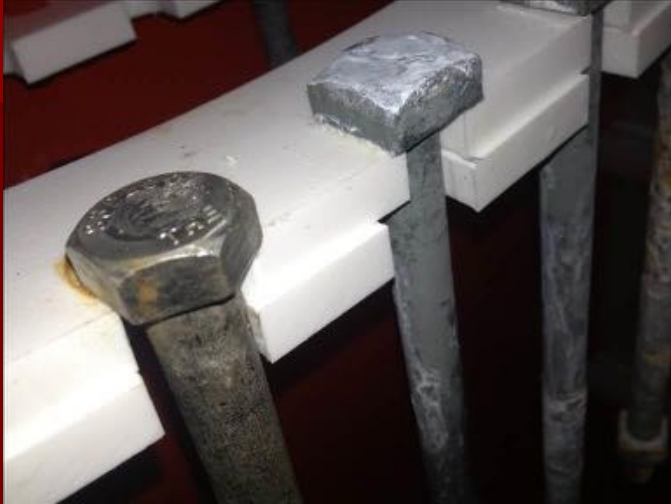
304 and 316 SS @ 500 Hrs

304 Status:

Minor corrosion point on head and chamfer.

No body corrosion

Fully functional threads, one minor corrosion point.

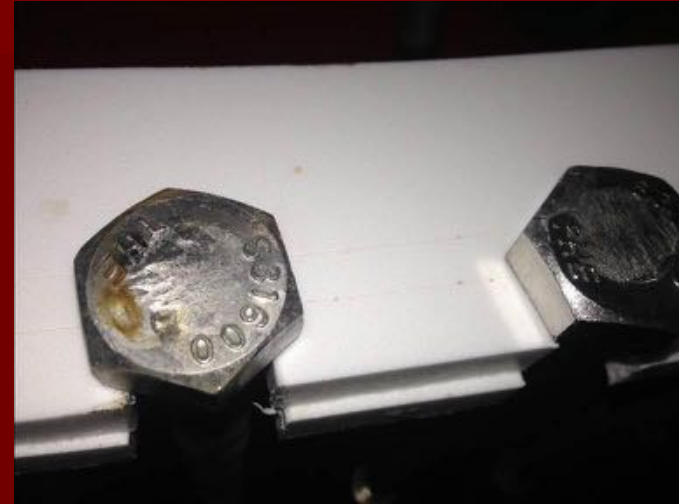
316 Status:

Minor corrosion point on head and chamfer.

No body corrosion

Fully functional threads, no corrosion

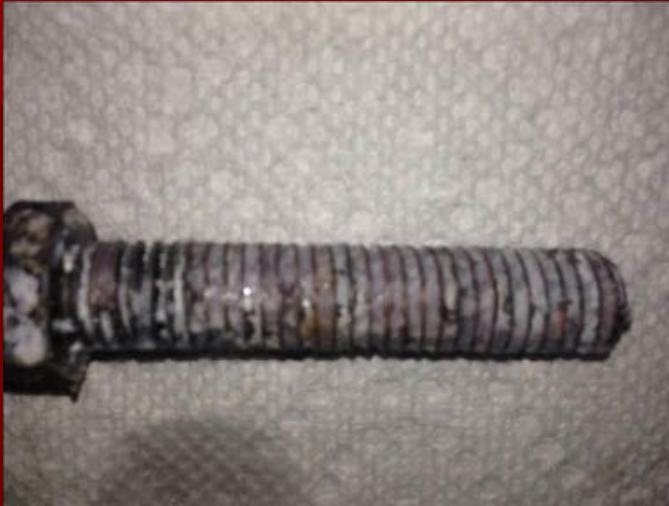
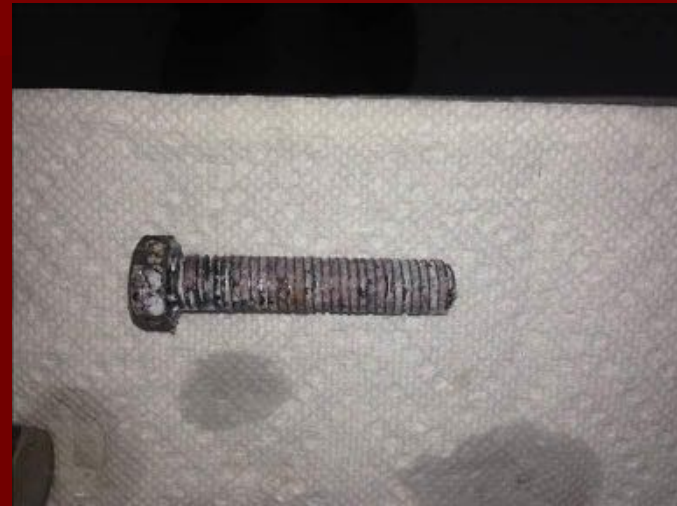
Aluminum @ 500 Hrs

Status:
Heavily corroded
unusable

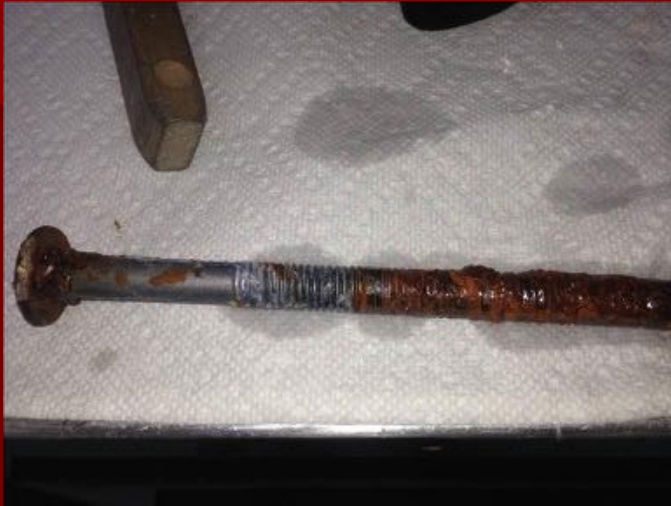
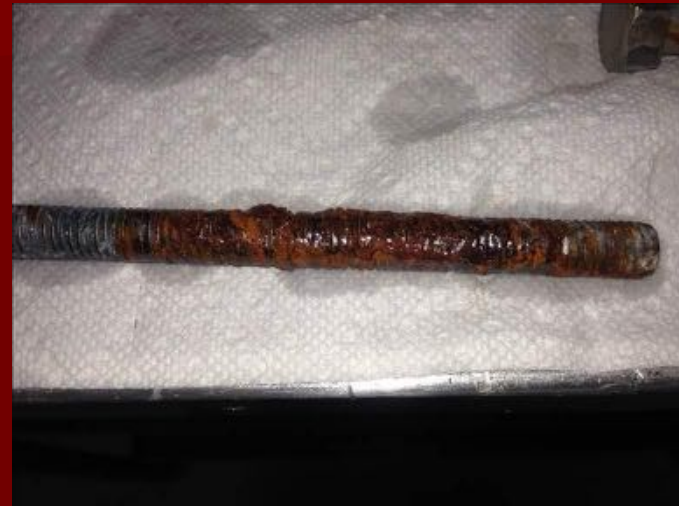
Electroplated Zinc @ 500 Hrs

Status:
Heavily corroded
unusable
