ArmorGalv® - THE ONLY TRULY “GREEN”, HIGH PERFORMANCE, CORROSION PROTECTION FOR STEEL.

ArmorGalv[®] as a replacement to HDG and other coating systems

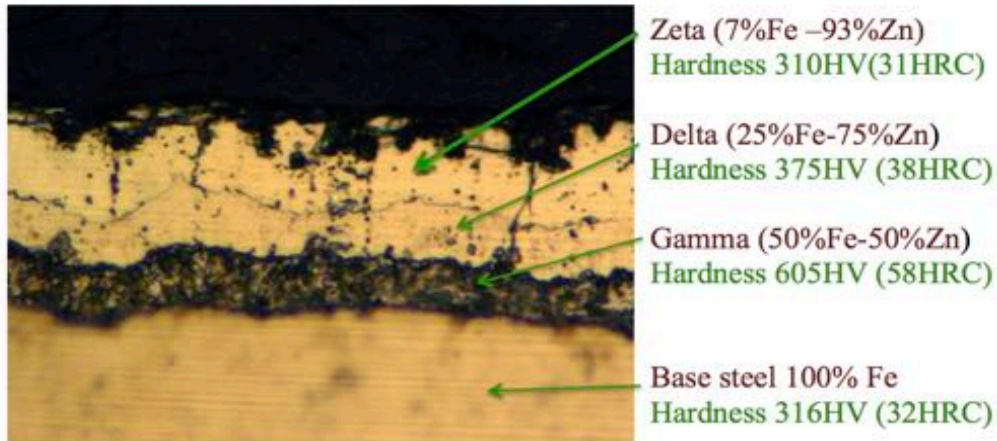
ArmorGalv[®] cross section

ArmorGalv[®] has a 100% intermetallic alloy structure, with a significant Gamma layer and a more iron rich structure than HDG. The **ArmorGalv[®]** layer is hard and abrasion resistant while the richer iron content also provides superior corrosion resistance.

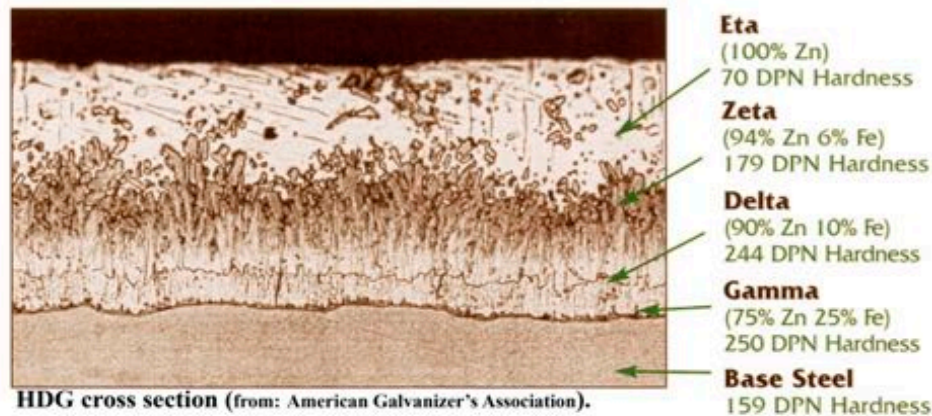
HDG cross section (from: American Galvanizer's Association).

HDG, most of the time, has a pure zinc layer that is more than half of the coating. The intermetallic alloy layers are much thinner (particularly the very thin Gamma, which is the hardest and most corrosion resistant) and poorer in Iron content.

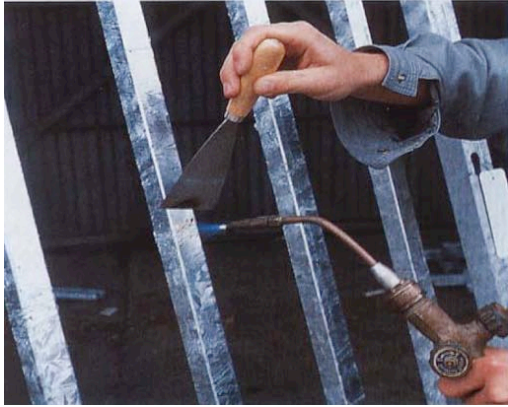
Zinc runs need to be removed and cleaned up, manually, after HDG.

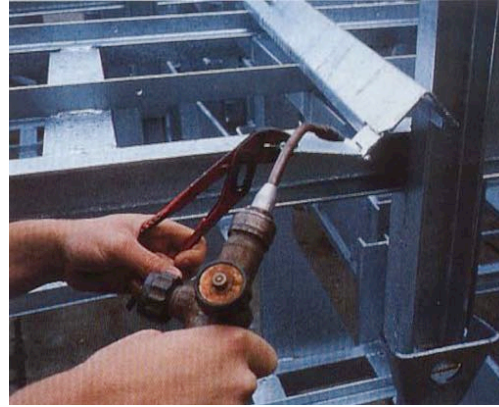
Moving parts and hinges need to be freed manually

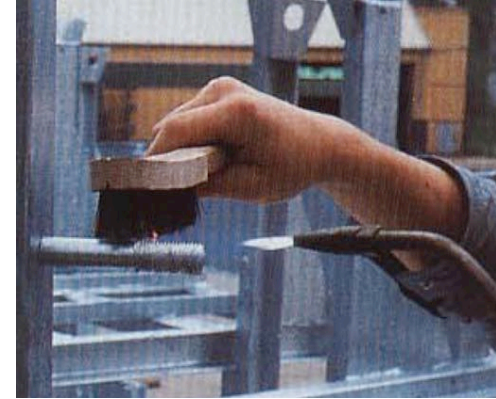
Threaded parts must be cleaned manually. Nuts are threaded after coating, so there is no protection on the inside thread.

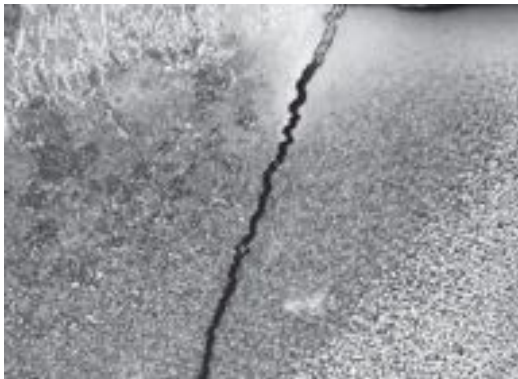
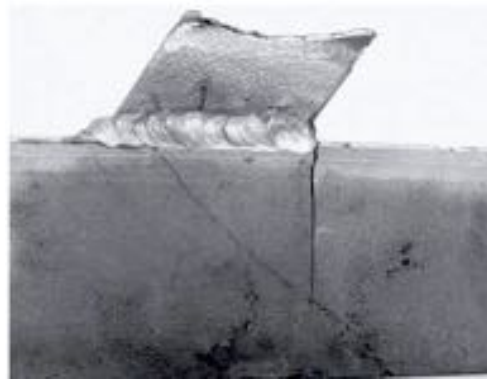
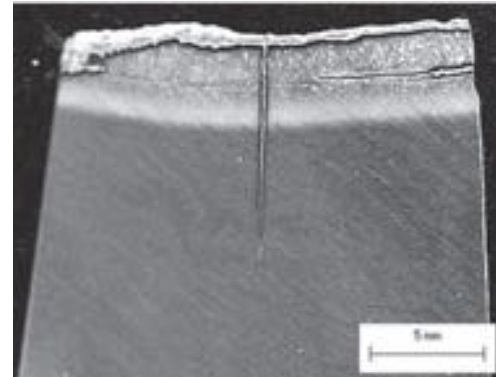
Hydrogen and molten metal (liquid) embrittlement failures:

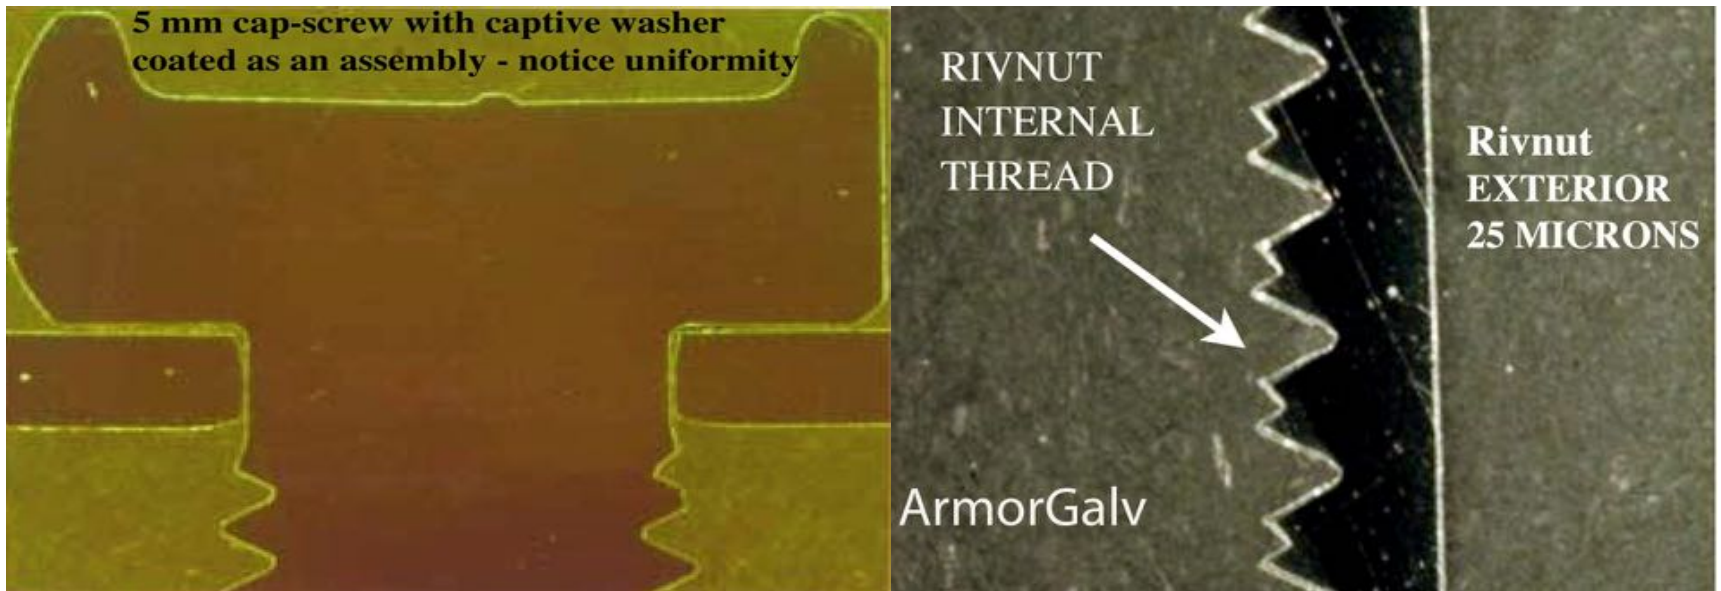
As can be seen from the uniform coating even between the washer and body of the screw, **ArmorGalv®** works well even on assemblies.

Unlike HDG, the **ArmorGalv®** technology creates an extremely uniform and controlled alloy layer. Due to the fact that we are dealing with zinc vapor (gas), which penetrates any open cavity in the part, **ArmorGalv®** is not sensitive to the geometry of the part and will coat internal surfaces of a part just like it does the external surface. This means, for instance, that unlike HDG nuts which get cut after galvanizing, leaving the inside thread unprotected, **ArmorGalv®** provides even and uniform protection to both the outside and inside threads.

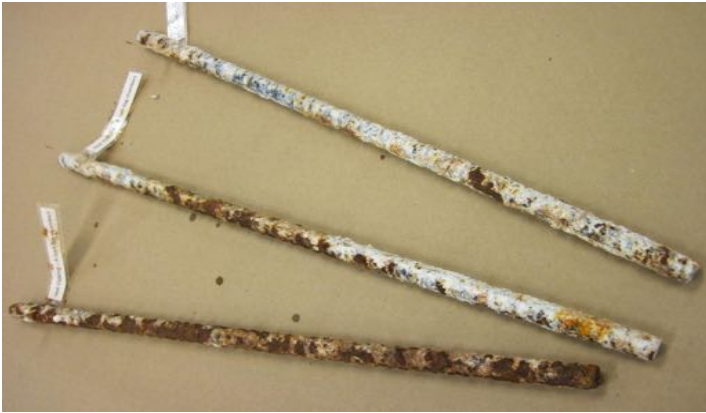
Figure 3 Traditional Hot Dipped galvanizing after 3000 hours in salt fog exposure

Part of a long-term corrosion test performed by the Florida Department Of Transportation, showing a side by side comparison of HDG and **ArmorGalv[®]**. While HDG coated rebar has completely failed after 3000Hrs (actually the failure started much earlier at around 600Hrs), the **ArmorGalv[®]** coated rebar showed no signs of corrosion at the end of the test. As can be seen from the cross section, after 3000hrs in the salt spray, the **ArmorGalv[®]** layer is still complete and intact.

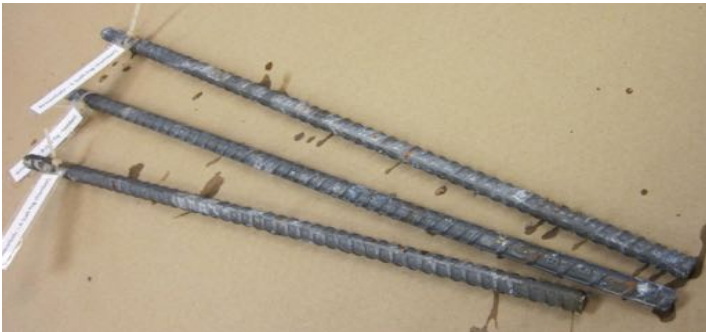
ArmorGalv[®] process showed limited visual signs of corrosion. (Figure 4.) There were a couple of rust colored spots that are most likely the result of surface contamination.

Figure 4 Armorgalv[®] process after 3000 hours in salt fog exposure

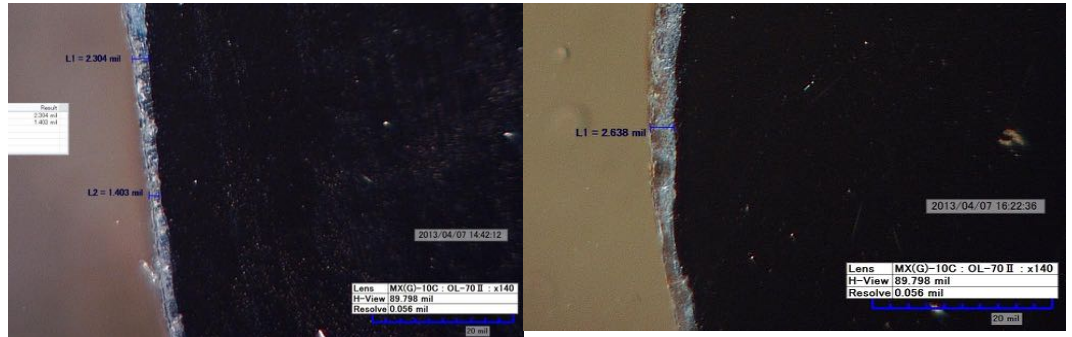
Figure 6 ArmorGalv[®] after 3000 hours in salt fog environment

Unexposed specimen

Specimen after 3000Hrs salt spray

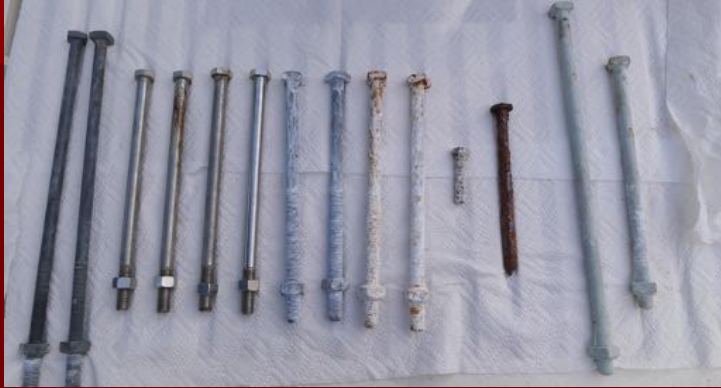
All @ 1500 Hrs

From left to right:
 TDG (2), 316 SS (2), 304 SS (2), Silicate Coated HDG (2), HDG (2),
 Aluminum (1), electroplated (1), ERX TDG (1), ERX HDG (1)

Shown is a page from a side by side salt spray test, conducted for Kortick Mfg., showing **ArmorGalv®** out-performing both HDG and 316 Stainless Steel. Also, unlike HDG, **ArmorGalv®** exhibits excellent **anti-galling** protection.

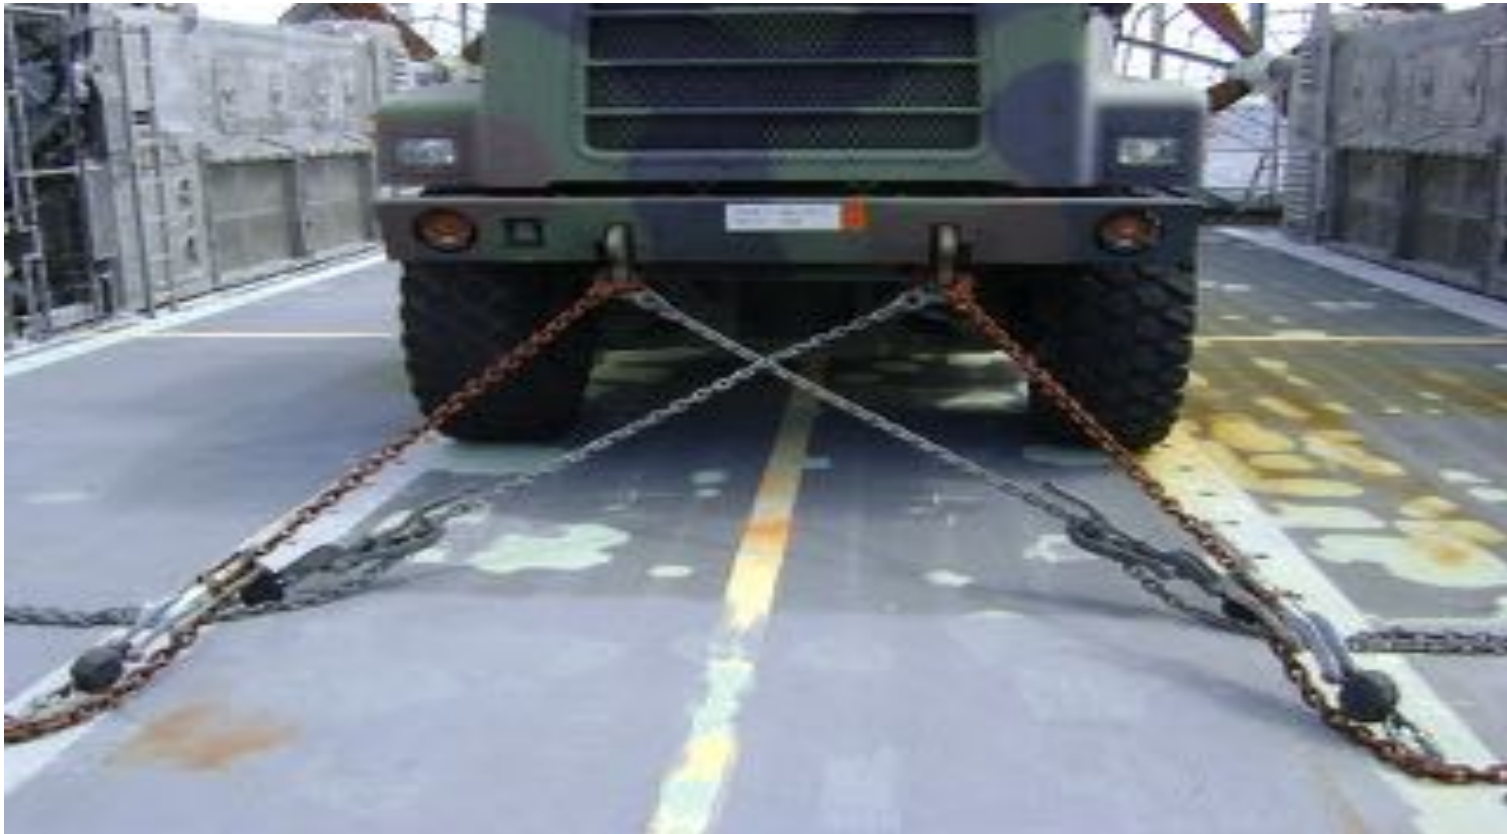
The inner pair of cargo lashings, manufactured by Spencer, were coated with **ArmorGalv**[®]. They exhibit no signs of rust after three years in the highly corrosive Gulf environment. The outer pair of legacy lashings, using standard materials and treatment, have significantly corroded over the same period.

After 3 years on the deck of an active U.S Navy hovercraft, HDG lashing is completely corroded while **ArmorGalv**[®] coated lashing, with grade 120 chain, shows no sign of wear or corrosion

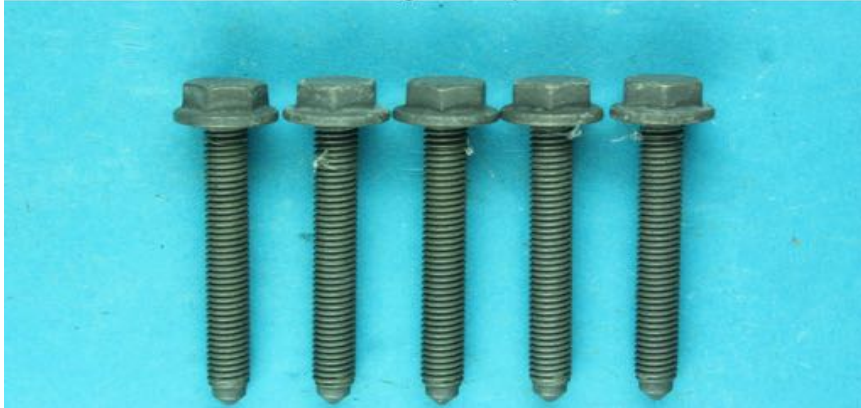
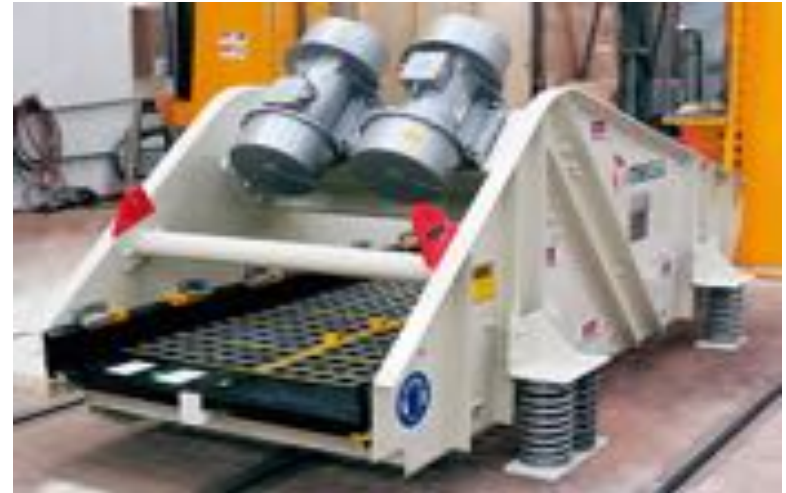
BENSELER NSS 2040h 20.08.2012
Kunde: Intern 04.09.01.62
6Kt. Schraube M6x46
Armorgalv + Tritop

*Grade 8 automotive bolts (2040hrs salt spray) - **ArmorGalv**[®] provides corrosion protection and improves fatigue performance* *Springs on vibratory mine screen -*

The **ArmorGalv**[®] process, by its nature, does not allow the hydrogen embrittlement process to occur. It does not involve acids and parts are processed at temperature for extended time, forcing hydrogen out. The natural micro-porosity of the **ArmorGalv**[®] coating allows hydrogen to escape. This has been proven through 100 years of field experience (including Sherardizing, which has a similar metallurgical structure) as well as laboratory testing. The **ArmorGalv**[®] process also provides **stress relief and improves fatigue performance**.

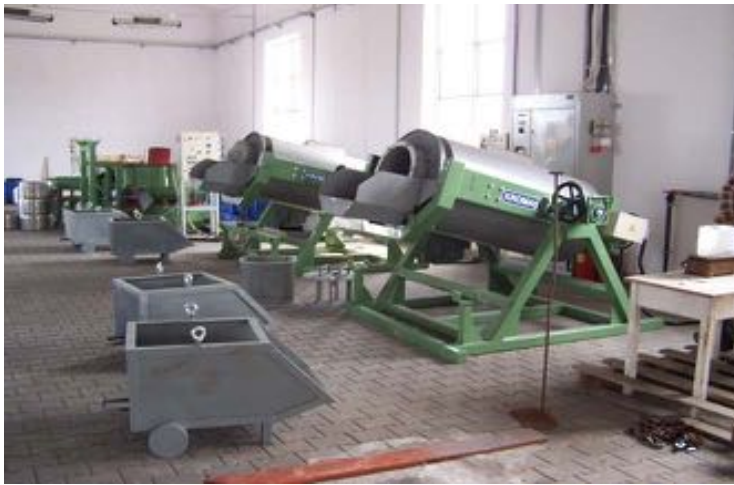
Small **ArmorGalv**[®] system

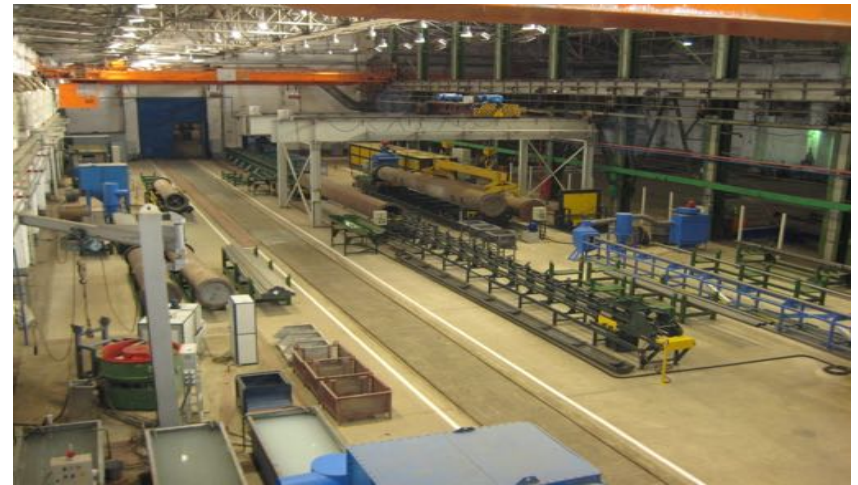
Large system for parts to 40ft long (12m)

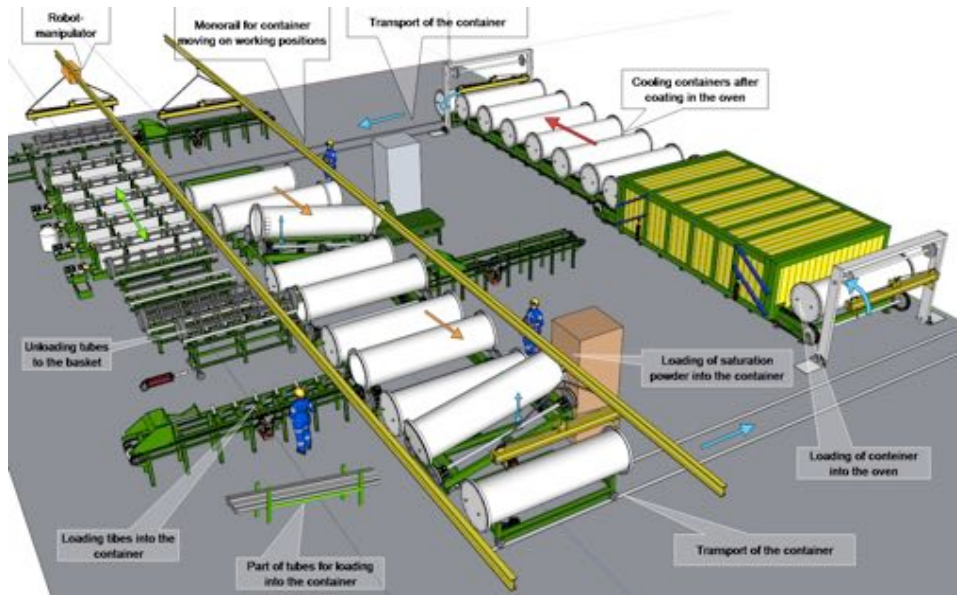
The **ArmorGalv**[®] process lends itself to highly automated facilities, as illustrated in the picture on the left, designed for automated processing of 3m (10ft) long tubes of various diameters. The tubes are evenly coated inside and out.

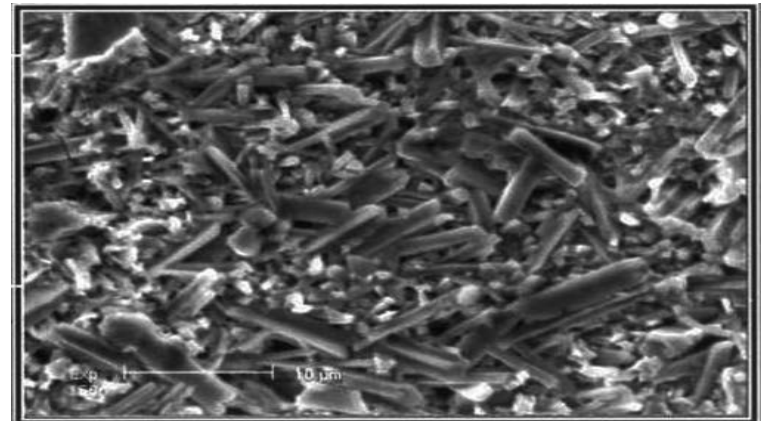
**ArmorGalv® BLUE DRILLED
48 Hours Sals Spray**

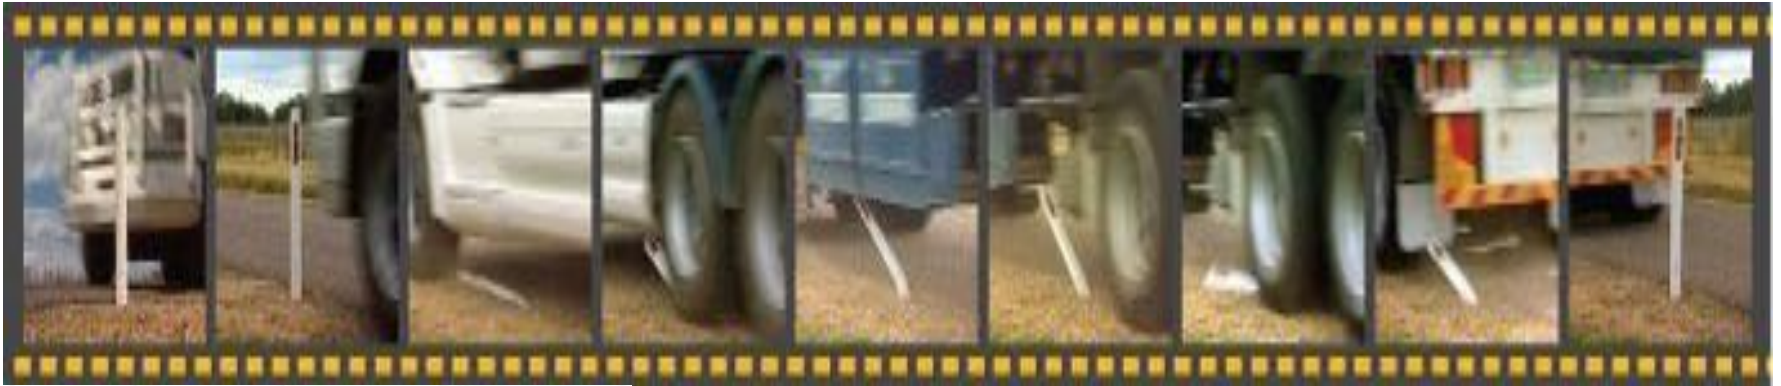
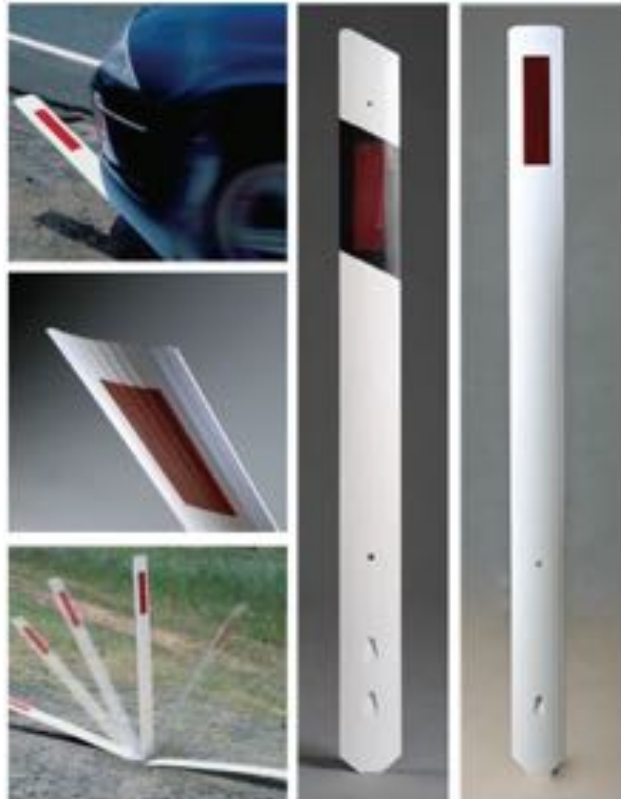
ArmorGalv[®] can be formed and bent after coating without loss of coating and corrosion performance

Delnorth Steel-Flex[®] roadside guide post is one of the most extreme examples of the ability of **ArmorGalv[®]** to withstand extreme deformation without loss of coating, or even paint adhesion. The **Steel-Flex[®]** spring steel roadside guide-posts, was developed by Delnorth International (Australia) and is being coated by the **ArmorGalv[®]** licensee ArmorGalv Aust. PTY Ltd. The post is made of a specialty spring steel and coated with **ArmorGalv[®]** and then powder coated. Testing the product entails 1500 cycles of a truck driving over the post, without it losing its flexibility, corrosion resistance and paint.

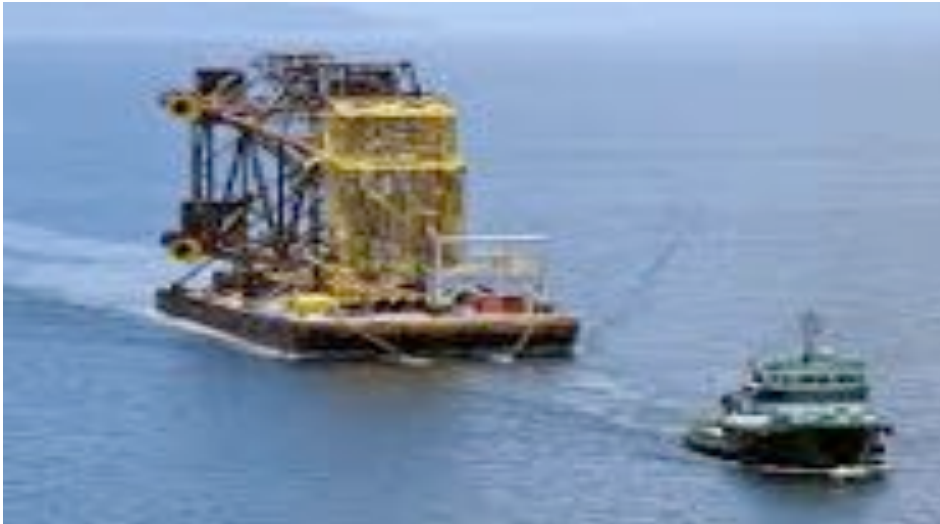
Barge towing chain in the north sea oil fields – a very critical application that involves protection from corrosion as well as wear and abrasion. A similar application is also chain used in fish farming.

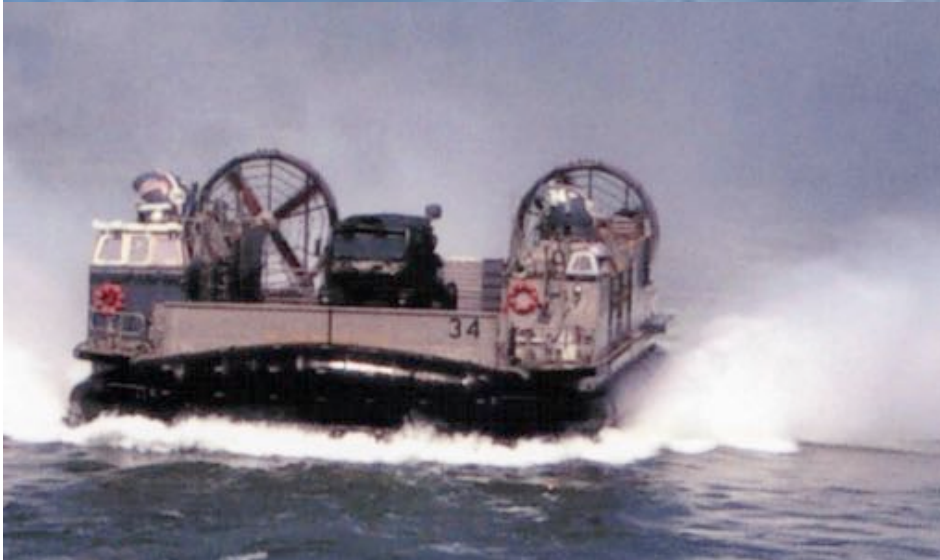
The U.S Navy fleet of hovercraft (LCAC's) is equipped with lashings made of G120 high tensile chain, protected with **ArmorGalv[®]**. This light weight chain is long lasting and offers about 35% in weight reduction.

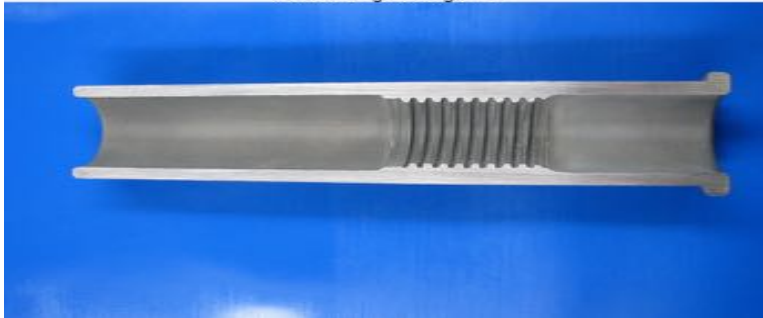
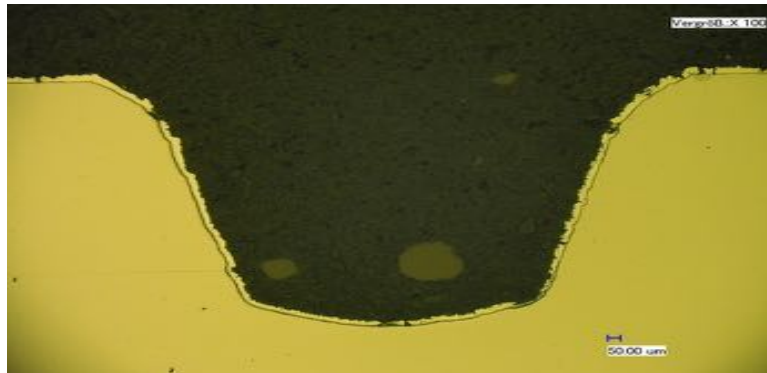
Benseler Langsschnitt 20.09.2013

Bauteilbezeichnung: Abschleppbuchse
Beschichtung: Armorgalv - T

Cross section through the center of the thread

Above part is an **ArmorGalv[®]** protected tow bushing, which gets welded to the car frame and is used for towing the car in emergency applications. This part must be functional for the life of the car. Here **ArmorGalv[®]** replaces specialty stainless steel.

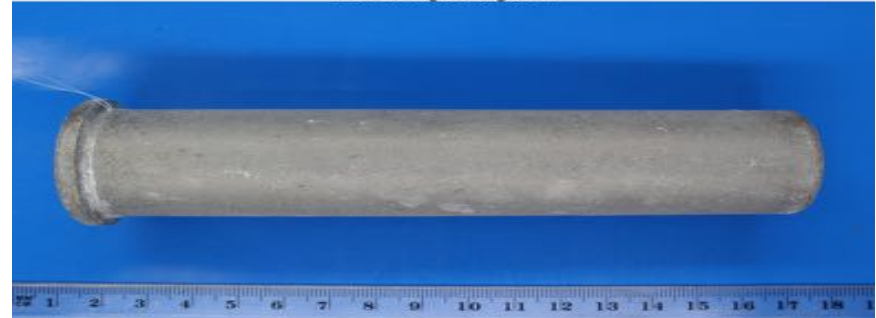
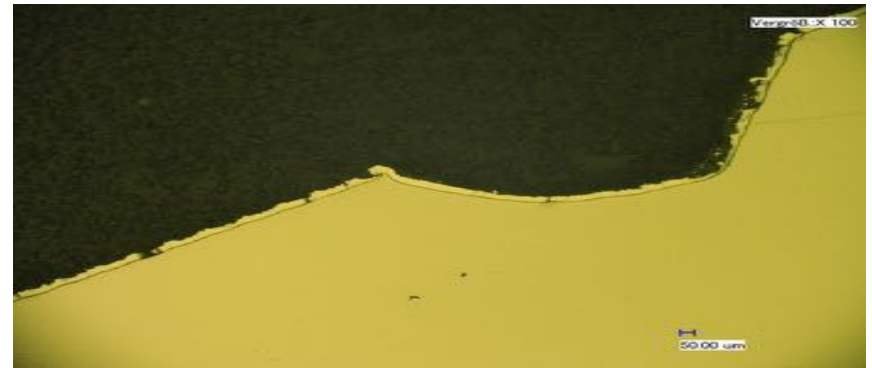
Benseler NSS 2040h 27.12.2013

Bauteilbezeichnung: Abschleppbuchse
Beschichtung: Armorgalv - T

Cross section through the end of the thread

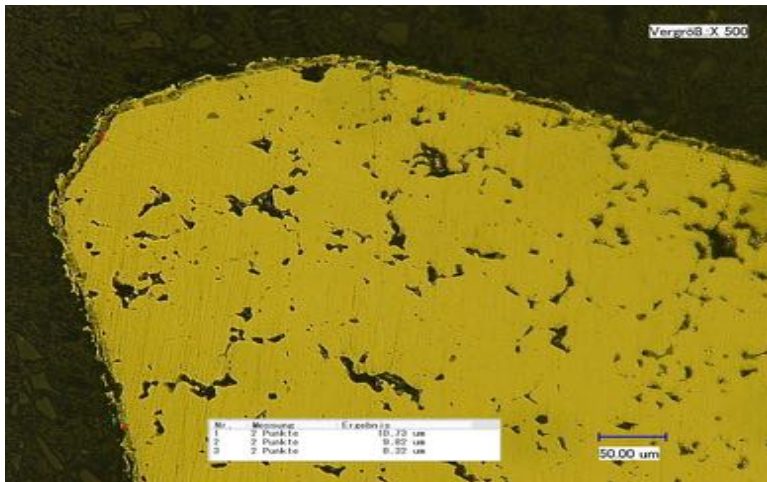
Cross section through a tooth

Sintered metal is the preferred, most cost effective method for manufacturing complex parts. **ArmorGalv®** helps expand the use of sintered metal by eliminating the need for polymer impregnation and greatly improving corrosion resistance and mechanical properties, as well as paintability.

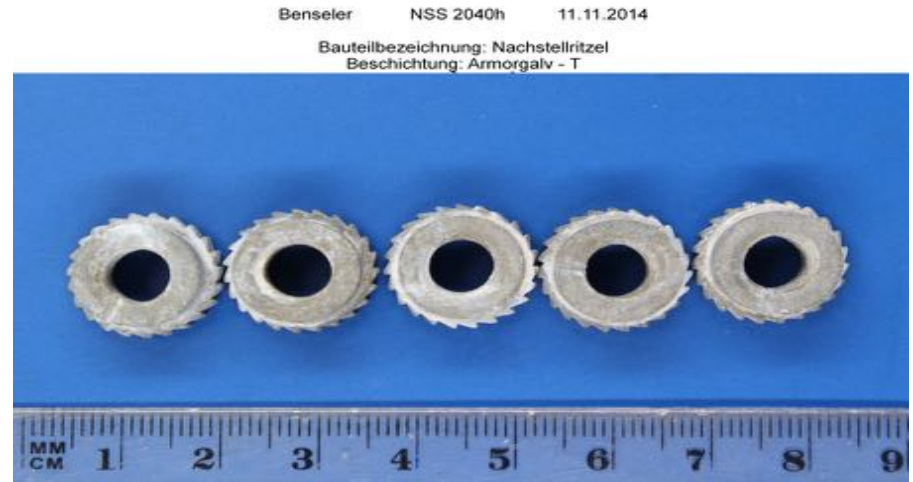
Sintered steel ratchet wheels (2040 Hrs salt spray)

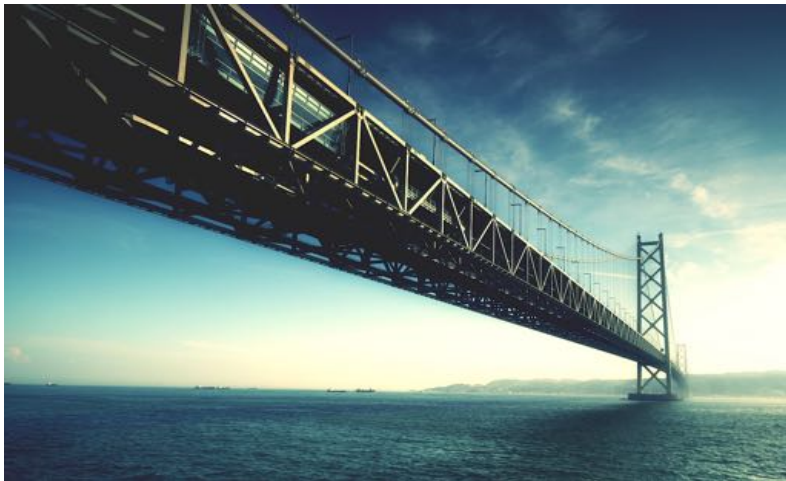
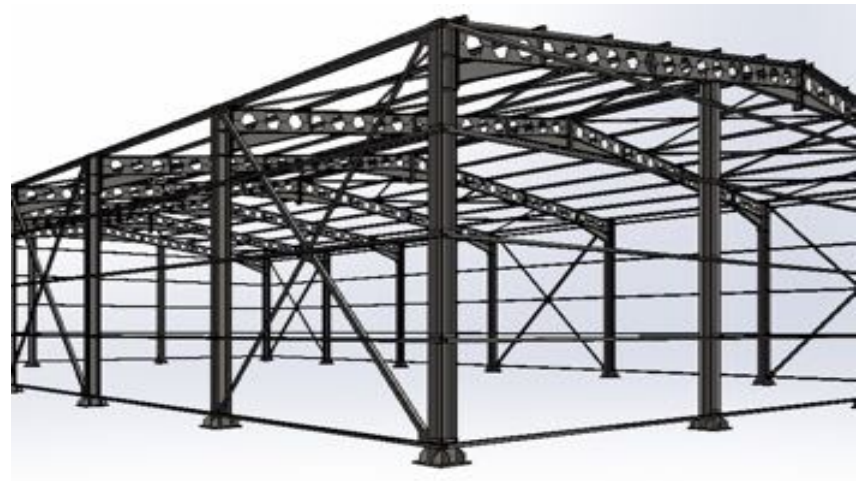
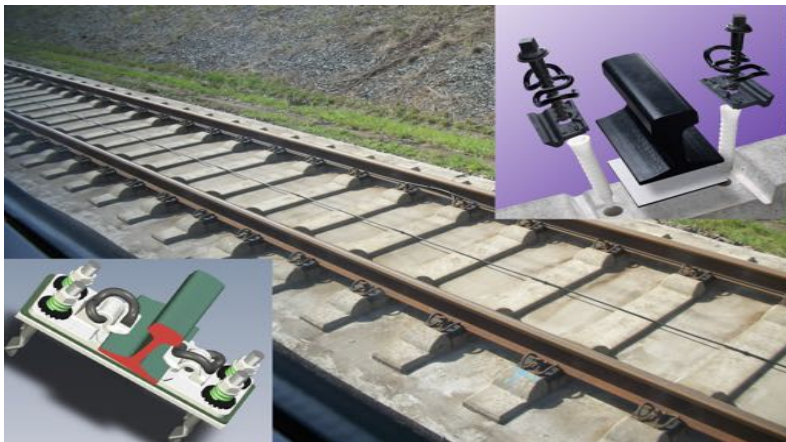
Railway fasteners across Europe and Australia are protected with **ArmorGalv®**.

The railway clips are made of spring steel. **ArmorGalv®** protects them against corrosion and prevents them from seizing.

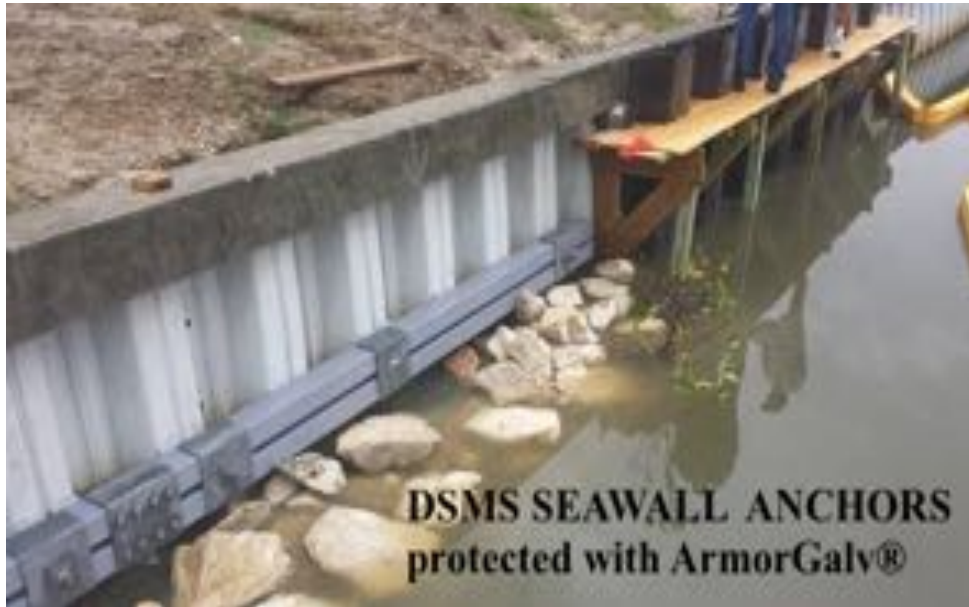
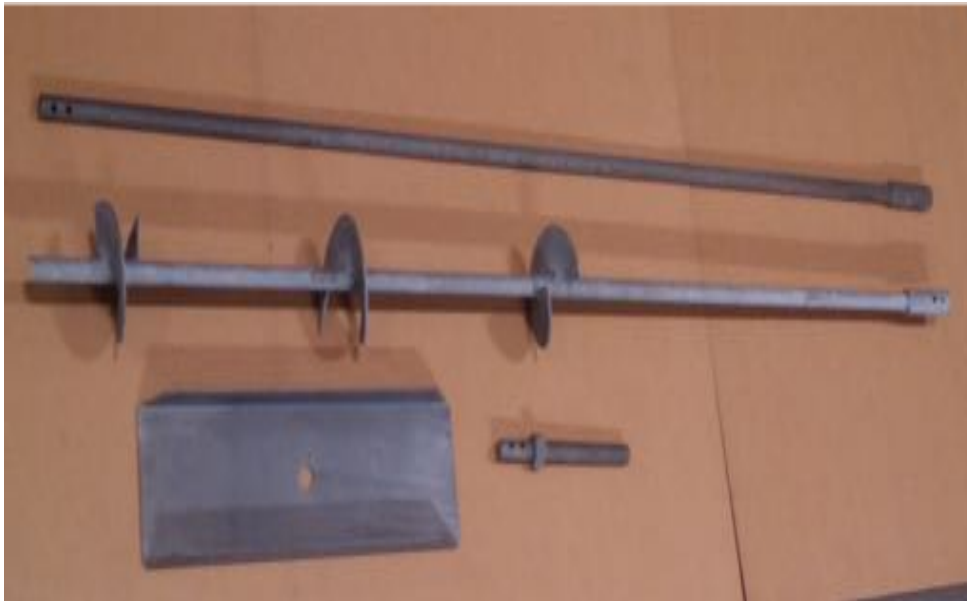
Dynamic Seawall Maintenance Systems provides a good example of using **ArmorGalv®** to protect steel in extreme marine environment, also involving high wear and abrasion resistance. After being drilled into the ground, the seawall anchor provides long term protection for the seawall from seawater and wave action.

The shaft with the helix is drilled into the ground. The bolt holding the support plate gets threaded into the end of the tube to hold the concrete seawall plate. All parts are coated with **ArmorGalv®**

ArmorGalv® coated carbon steel has **replaced stainless** steel in this application.

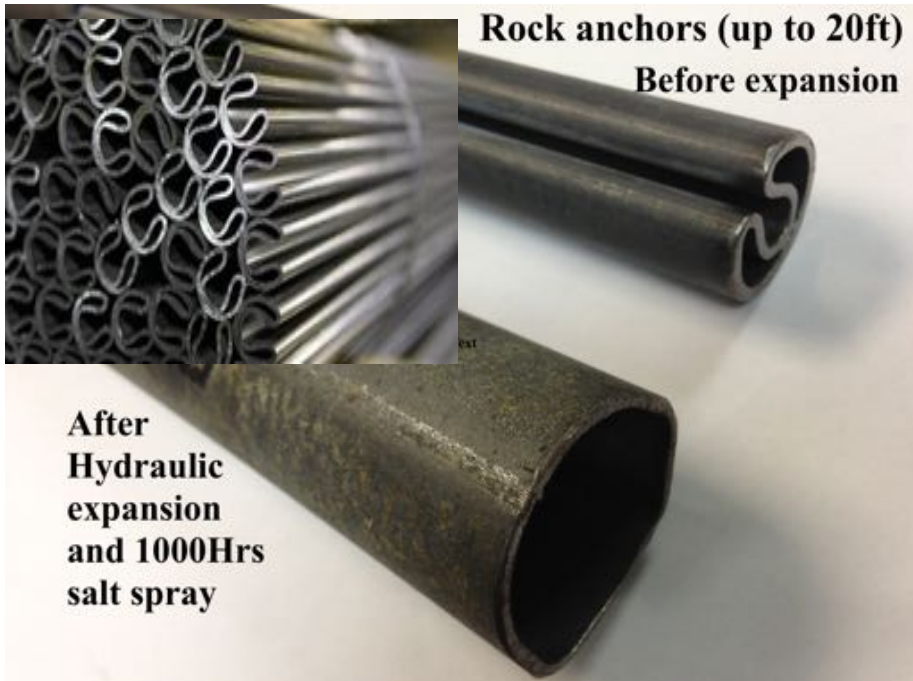
Rock anchors (up to 20ft)
Before expansion

After
Hydraulic
expansion
and 1000Hrs
salt spray

The rock anchor is one of the products that take advantage of the fact that **ArmorGalv[®]** coated steel can be formed after coating, without losing its corrosion protection.

The rock anchor is an extreme example of this. Having gone through severe deformation, it is expected to provide long-term corrosion protection in the corrosive environment of a mine.

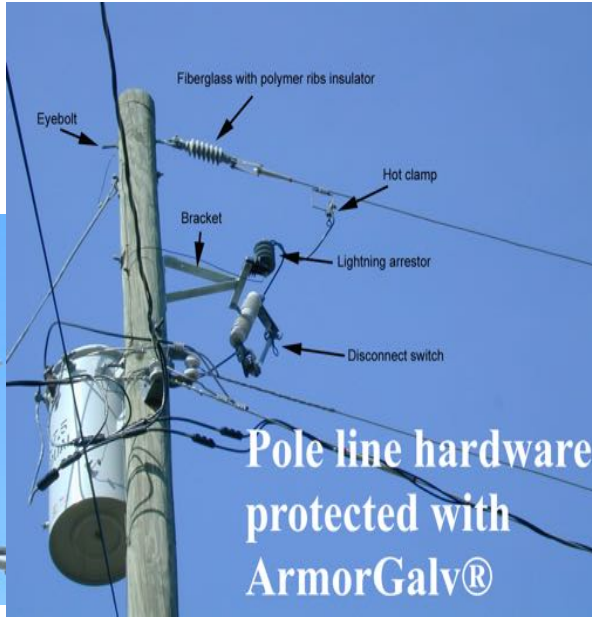
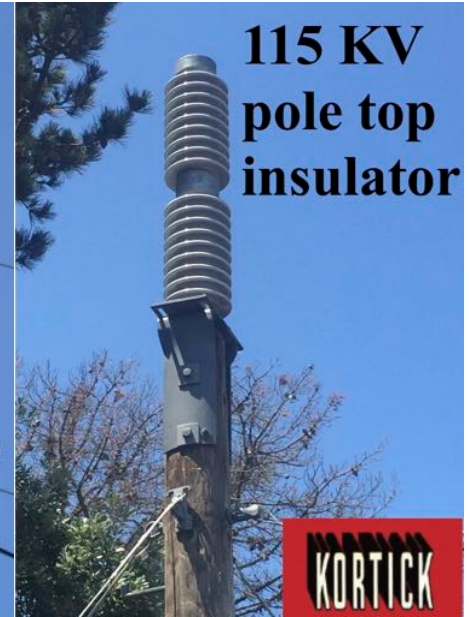
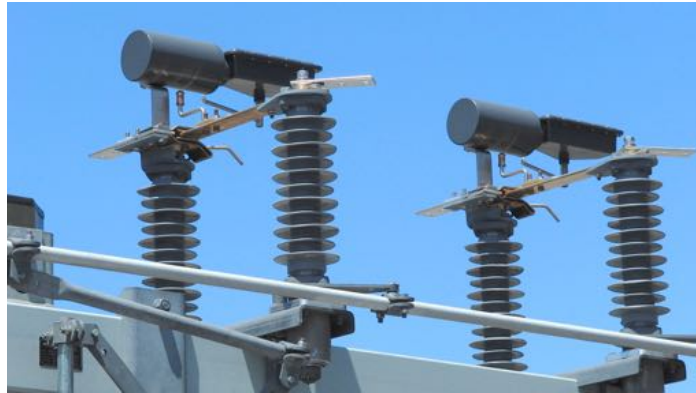
High voltage switch.
All steel parts are
protected by
ArmorGalv®, replacing
Stainless Steel

Power utility companies are now specifying **ArmorGalv®** as the preferred coating for pole line hardware and other equipment, replacing HDG and stainless steel. Solar and wind power installations use **ArmorGalv®** protected hardware.

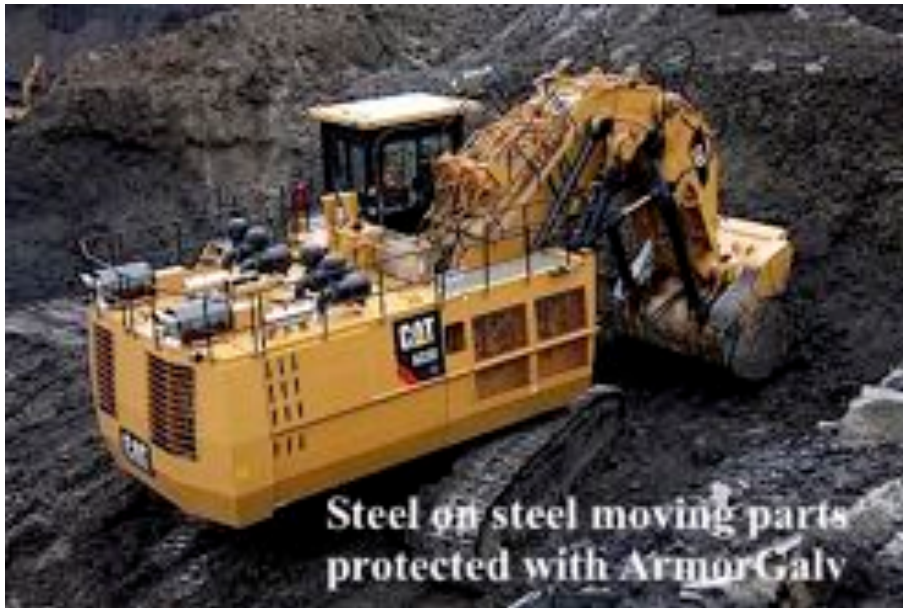
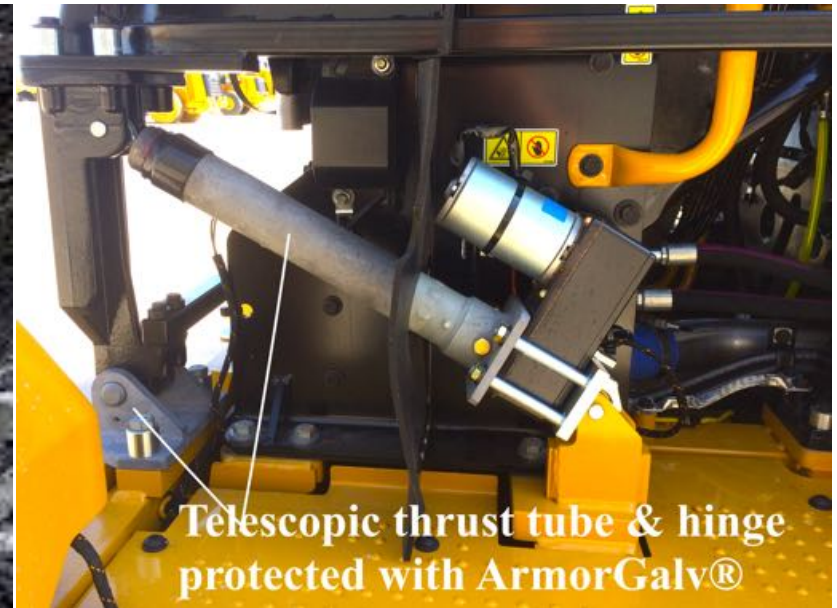
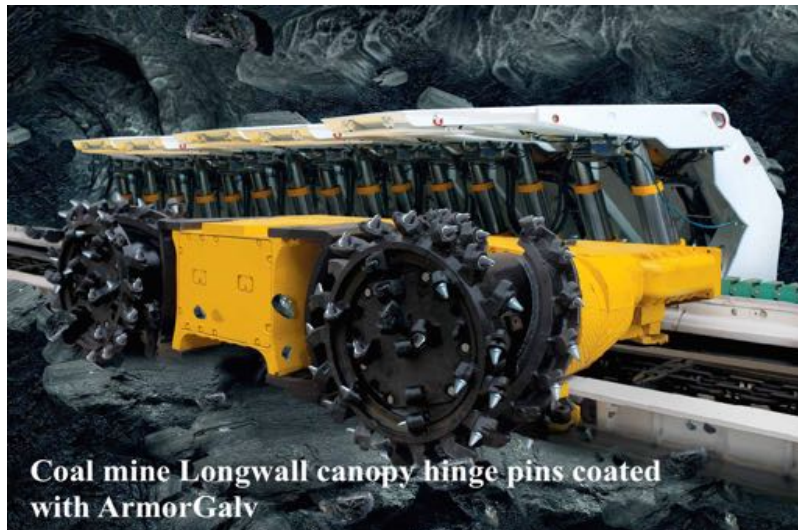
In the extremely abrasive and corrosive environment of coal mining, equipment designers have taken advantage of the excellent abrasion and wear resistance of the **ArmorGalv®** technology, as well as the long term corrosion resistance. This is particularly true in critical applications, such as heavy equipment and the longwall hinge pins that must guarantee no seizing of the hinges.

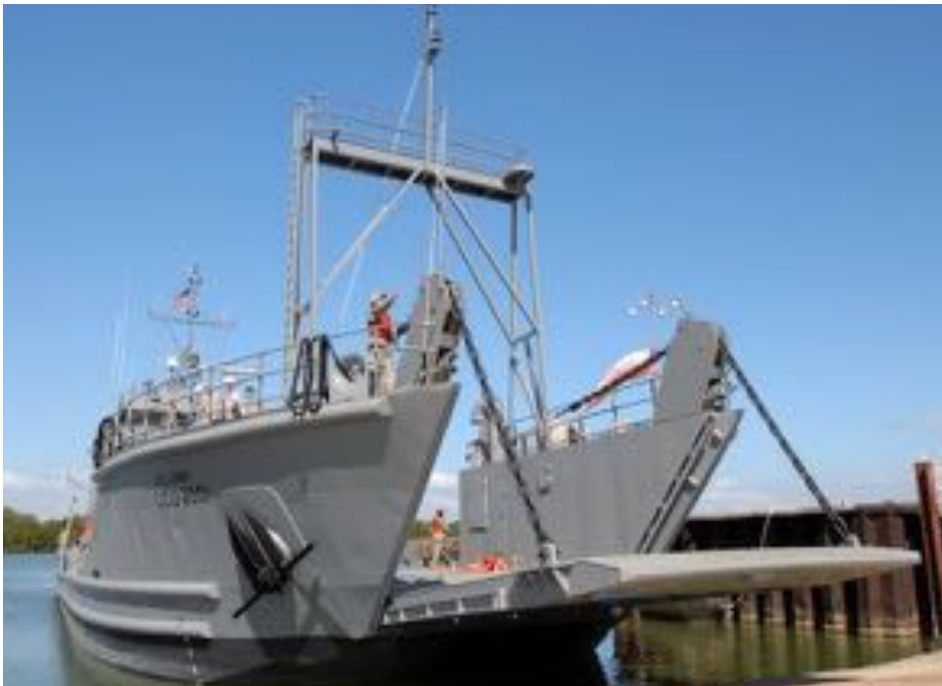
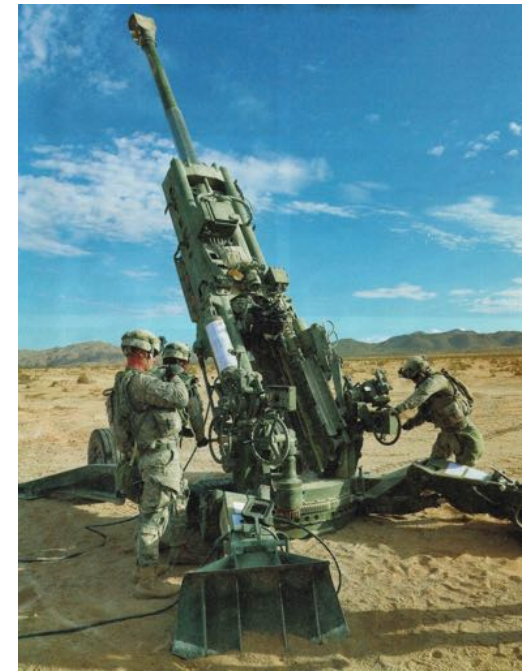
The U.S Army fleet of landing craft is being equipped with **ArmorGalv®** protected anchor chains and bow chains, drastically reducing operational issues and maintenance costs of these parts.
