ARMORGALV® EXCELLENT RESULTS

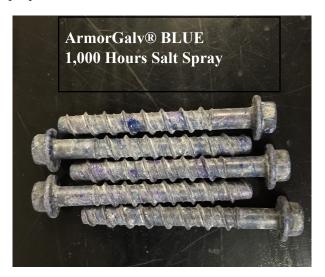
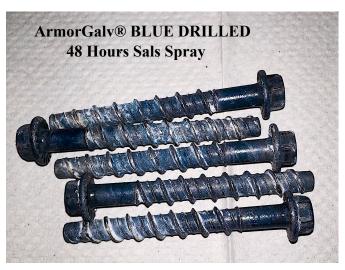
Below please see Tapcon parts that were coated with **Armor** *Galv*[®] **BLUE**. Please note that the parts on the right were drilled into concrete and removed and still exhibit the blue color after 48 hours of salt spray. The **Armor** *Galv*[®] Base Coat will allow ANY paint to exhibit this phenomenon because it acts like a "sponge" to absorb paint BELOW the surface. The next pages shows the drilled parts after 1,300 hours of salt spray.

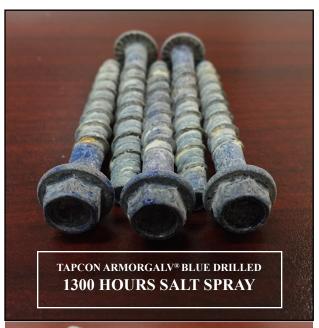
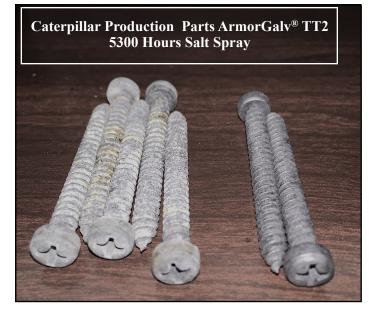
This explains why the **Armor***Galv*[®] BLUE can retain paint even after drilling:

Notice that the paint penetrates into the "fissures" of the **ArmorGalv®** surface. This prevents lateral corrosion pathways when the paint is compromised or damaged, thus eliminating paint-peel.
