Feb 6, 2013 Letter Report No. 100861285MID-005
Project No. G100861285

Subject: Corrosion UL 2703 section 19.2

The UL 2703 section 19.2 corrosion test has been completed on your submitted Daetwyler Clean Energy 500402495 Samples. The Daetwyler Clean Energy 500402495 Samples were coated with ArmorGalv, which is a zinc thermal diffusion coating per ASTM A1059 – class 25. Samples were submitted to Intertek for analysis consisted of the following: One Bolt and one zinc plated reference specimen.

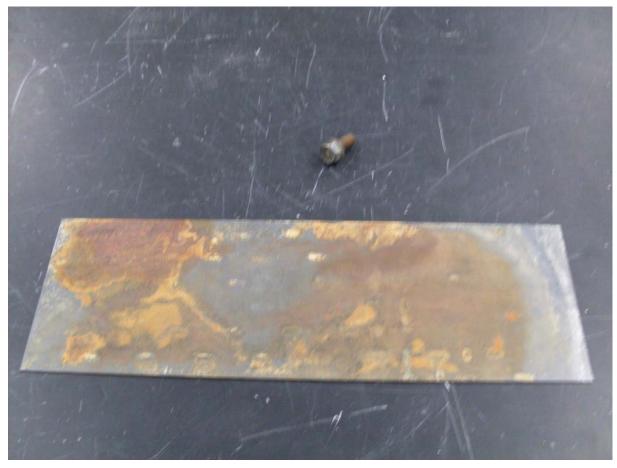
Pictures of the corrosion after the eleventh day and test completion are below.

Both the sample and control were washed in DI water to remove oxide reside. The sample bolt was compared to the control plate (both sides and scribed area).

The control had very little corrosion on the upper side and no corrosion in the scribed area. The lower side of the control had corrosion on approximately 50% of its surface. Both sides of the control together have approximately 25% corrosion.

The sample bolt had approximately 2% corrosion on its head area. The scribed area showed no corrosion.

The results of an evaluation of the coating system of sample bolt Daetwyler Clean Energy 500402495 demonstrated that it provides protection at least equivalent to that provided by the zinc coating as described (ASTM G90) in 10.2(a).

This specimen passed the criteria for UL 2703 section 19.2
